## The New Kelani Bridge

By M. CHANDRASENA, B.Sc. Eng. (Lond.), A.M.I.C.E.

### SYNOPSIS

The New Kelani Bridge is a reinforced concrete structure spanning the Kelani Ganga approximately half a mile upstream of the Victoria Bridge and two miles from the mouth of the river. This bridge which is the longest bridge in the Island is 900 feet in length and consists of 10 spans varying from 70 feet to 107 feet. It provides for a dual carriageway each 29 feet wide and two footways each 10 feet wide.

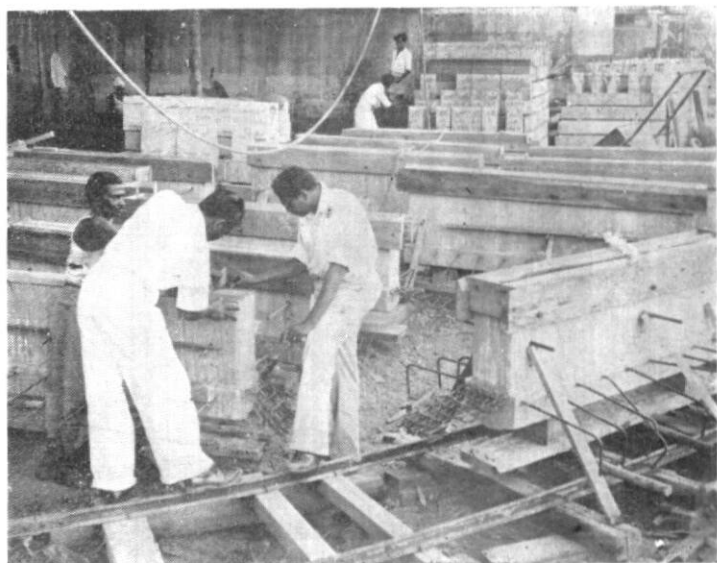
Fig. XI. Checking R.C. rollers (precast).

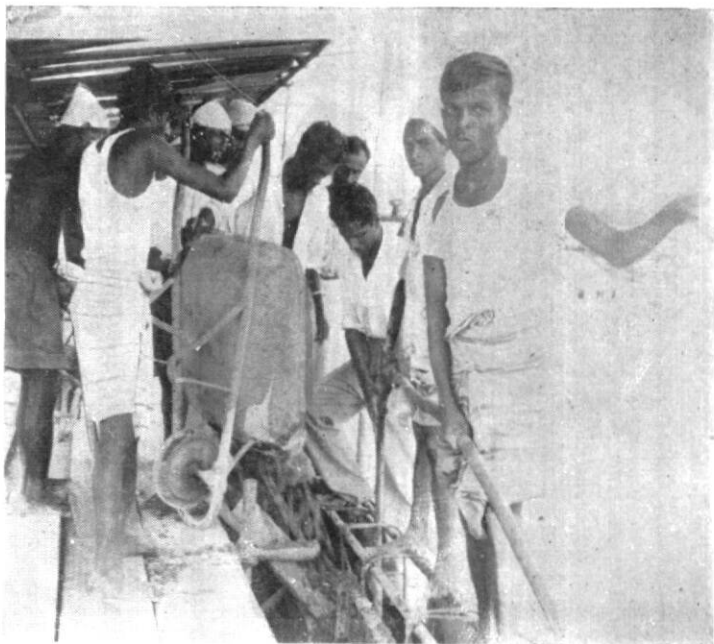
Fig. XII. Concreting of a parapet beam.
